CORROSION COMBAT

Contamination of Chemical Process Product by Corrosion of Process Vessel: A Case Study

Burner Tip Failure in a Reformer of a Petrochemical Plant

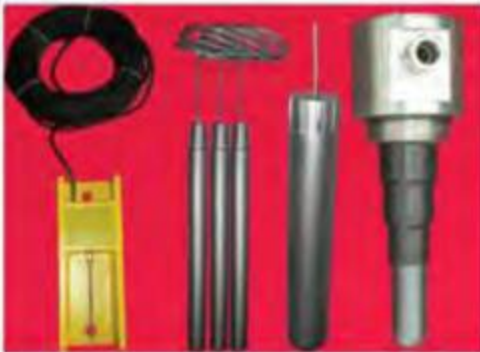
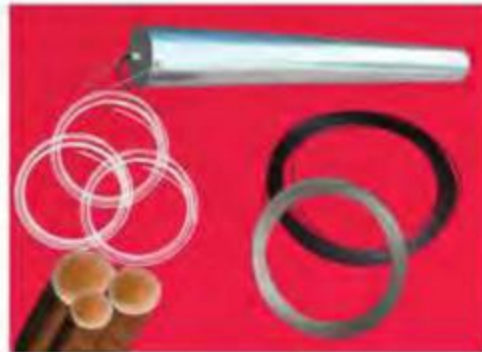
Photograph 1

The following forms of corrosion have occurred in the wetted parts of the agitator assembly:

1. General uniform corrosion resulting in uniform overall roughness and reduction in effective wall thinning in general. (See Photographs 1 and 2 below).

Thus it is **diagnosed** that the problem of brown contamination of the organic chloride powder is due to corrosion of internal components made of 316L stainless steel making up the agitator assembly.

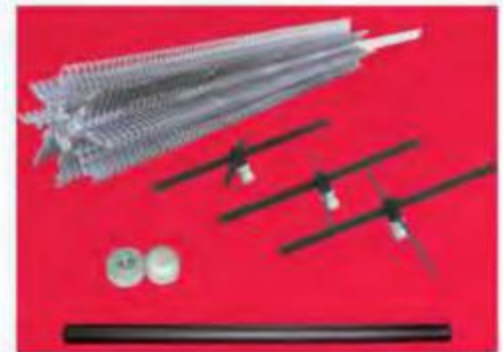
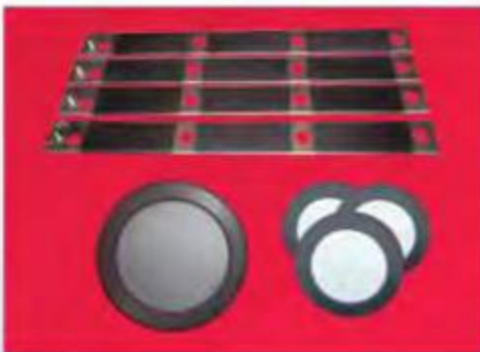
2. Pitting corrosion in all wetted parts: a form of localized accelerated corrosion resulting in deep pits, either highly localized or throughout the surface, typical of corrosion of stainless steels in chloride solutions well above the atmospheric temperatures (See Photographs 3 and 4 below).

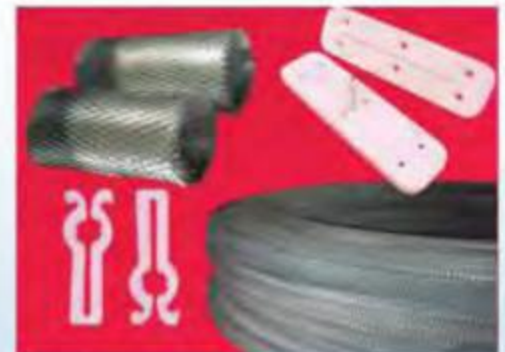
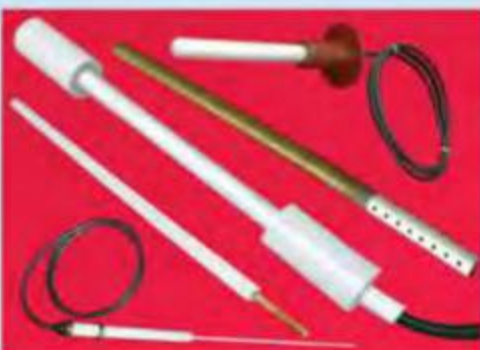
Photograph 5

3. Crevice corrosion. A form of highly localized corrosion occurring inside the crevice formed within mechanical joints, like keyways, spacer-shaft areas, gasket grooves etc., also typical of stainless steel corrosion by chloride solutions wherever crevices are present. (See Photographs 5 and 6 below).

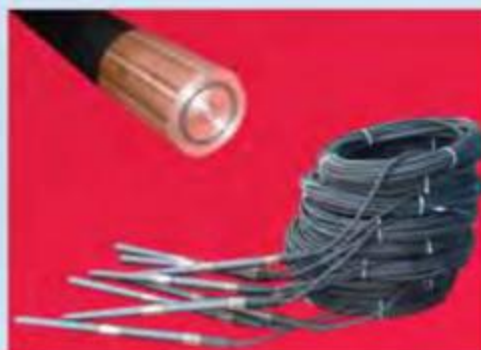
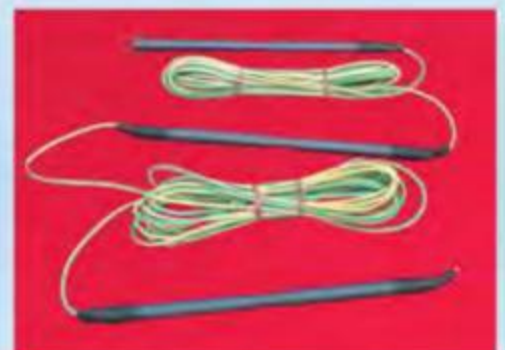
4. Stress Corrosion Cracking by Chloride (CSCC). This is an intense form of highly localized corrosion occurring in stainless steels in areas where tensile residual stresses are present simultaneously with chloride contact. This form of corrosion, CSCC, shows up in the form of bunches of fine multiple cracks without noticeable corrosion (brown rust formation) in the adjoining areas and without wall thickness reduction. (See Photographs 7 and 8 below for CSCC in areas adjoining welds where residual stresses are present).

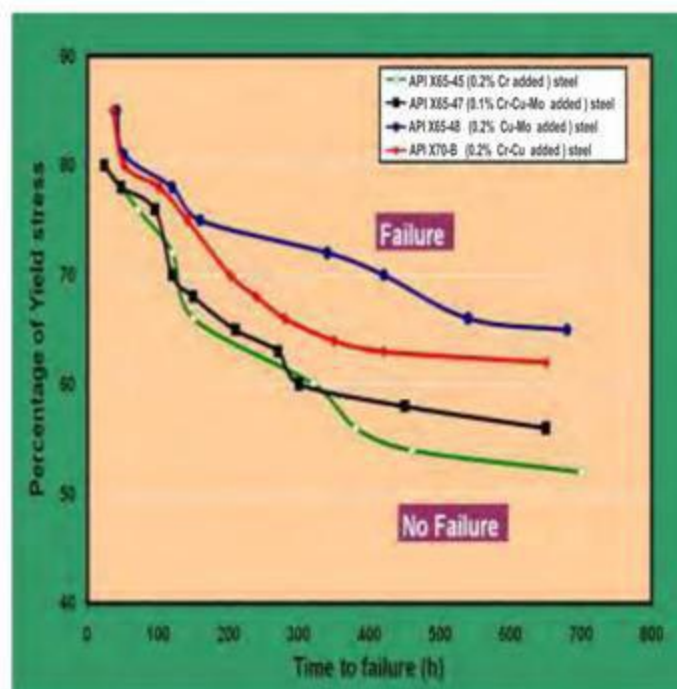
Figure 2 Sulphide stress corrosion cracking (SSC) studies of API steels as per NACE TM 0177 Method A

The SSC test were conducted as per NACE TM 0177 Method A [6] (Fig. 2), the threshold stress were evaluated to be 51% and 65% of the yield stress for Cr added API X65 and Cu added API X65 steel respectively. SSC for pipe samples were also evaluated and it was observed that Cr added pipe API X65 steel pipe showed poor in SSC resistance as that of the Cu added API X65 steel pipe. The SCC studies [7] (Fig. 3a) were also conducted to understand the qualitative nature of the failure. From the studies it was observed that addition Cu has increased the elongation and UTS value. Fracture surface observed under SEM showed that brittle kind of failure for Cr contacting API steel and mixed mode of failure for Cu containing API steel (Fig 3b and c).

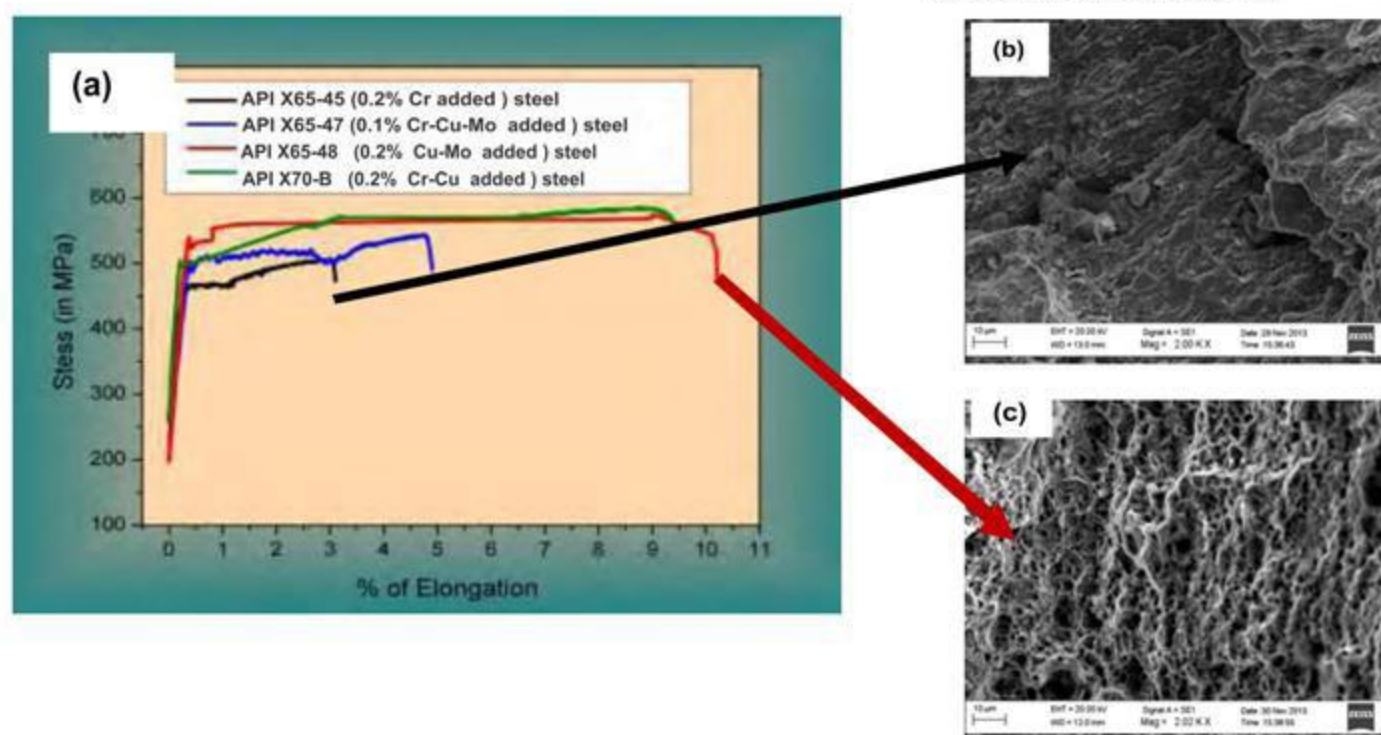
Figure 3 Stress corrosion cracking (SCC) studies (a) Graph showing Cu addition has increased ductility of the material in sour gas environment (b) and (c) Fractographs of fractured surface of API steels in SEM showing Cu addition has changed the morphology of cracking from intergranular brittle failure to mixed mode (brittle for river like pattern and ductile for dimple) failure

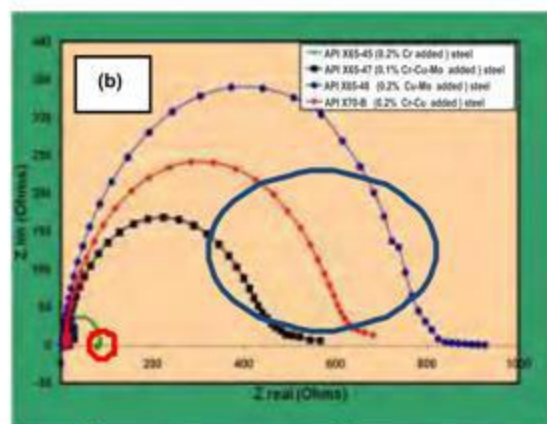
Figure 4 Electrochemical Corrosion studies plots of Cu-added API X 65 steels in sour gas environment (a) Polarization plots showing shift in corrosion potential towards noble potential and lowering corrosion current with addition of Cu (b) Electrochemical impedance spectra showing Cu addition has improved in impedance of the passive film and changed film characteristics

(Fig. 4b), where Cr containing steel showed a negative loop in the Nyquist plot correspond to inductance behaviour or chemisorption film (FeHS-ads) [9]. The Cu containing API steel showed absence of negative loop which corresponds to absence of chemisorption film (FeHS-ads). Hence, it can be concluded that Cu alters the surface reaction (avoiding the formation of adsorption film) and restricts the hydrogen ingress into steel, thereby increasing the corrosion resistance, HIC and SSC performance.
